**Test  
Report**

Our Ref: GBW Number 132579 Issue 1 Date 30/03/2015 Page 1 of 8

## SALT SPRAY TESTING OF GALVANISED STEEL PLATE / TUBE ASSEMBLY SAMPLE

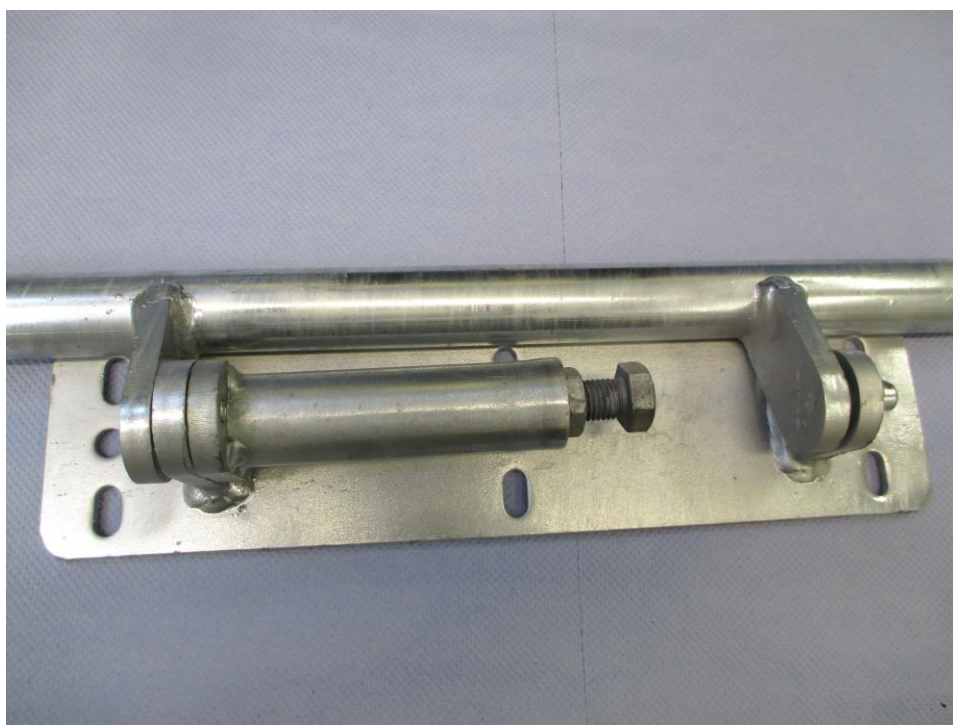
The photograph in fig 1 is showing the sample prior to test, the sample was then exposed to a neutral 5% Salt Spray for a test period of 336 and 672 hours, examinations after 72 hours and then every 24 hours, revealed the following observations:-

Fig 1: Photograph showing the condition of the Sample prior to Salt Spray Test

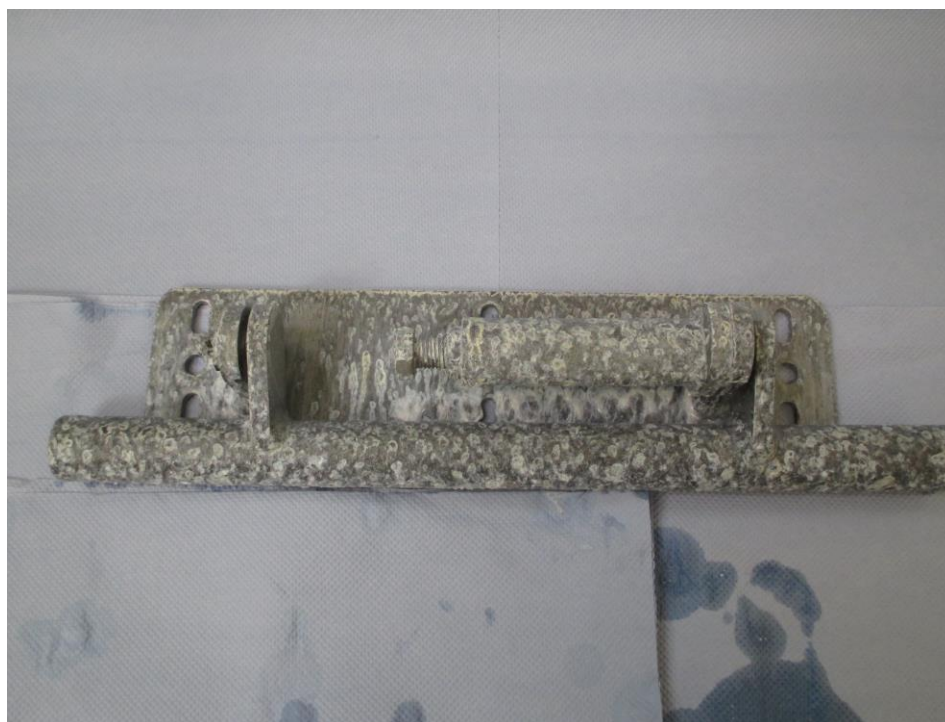
The sample showed evidence of total white zinc corrosion (see photograph).

Fig 2: Photograph showing the condition of the Sample after 72 hours Salt Spray Test

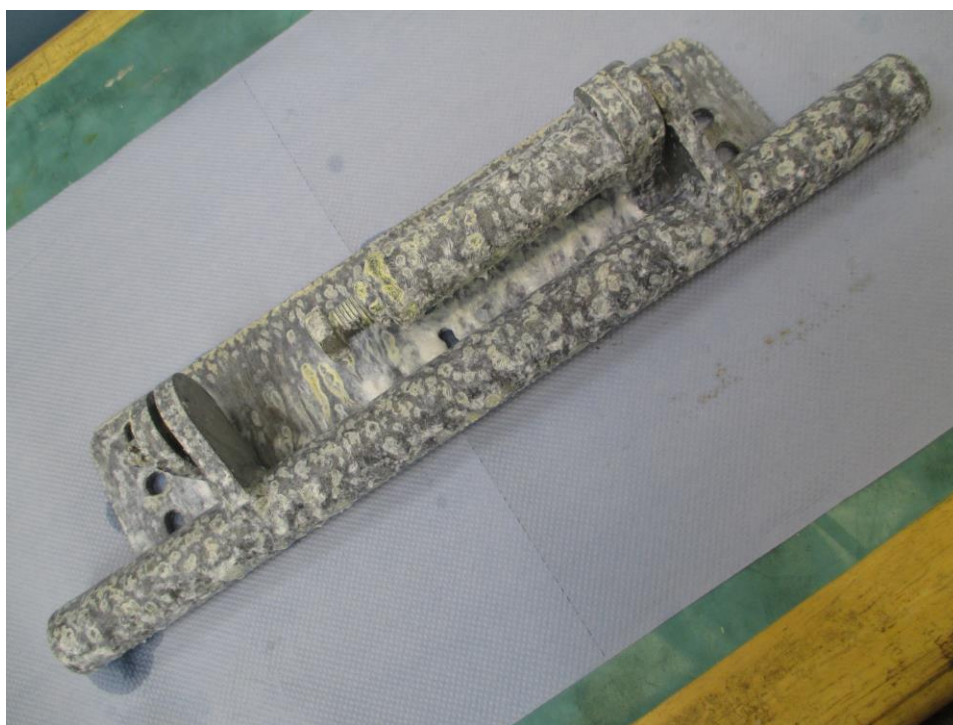
The sample showed evidence of moderate yellow corrosion product and total white zinc corrosion (see photograph after 144).

Fig 3: Photograph showing the condition of the Sample after 144 hours Salt Spray Test

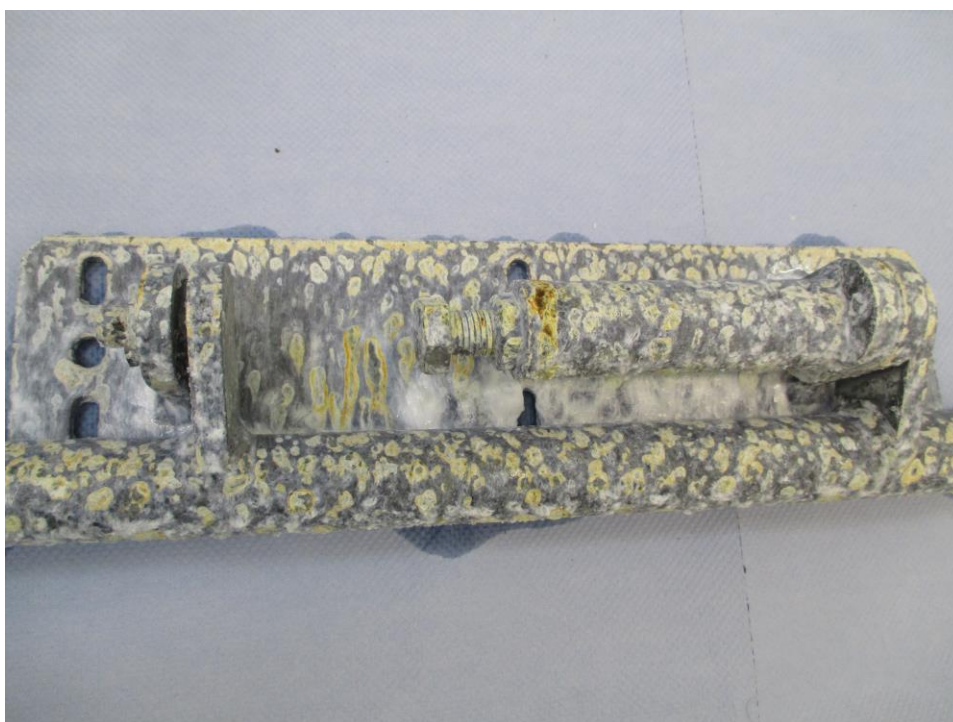
The sample showed a small area of red ferrous corrosion on the tube arm adjacent to the nut and a significant amount small spots of red ferrous corrosion 1.0mm maximum size and significant yellow corrosion product and total white zinc corrosion (see photograph after 240 hours).

Fig 4: Photograph showing the condition of the Sample after 240 hours Salt Spray Test

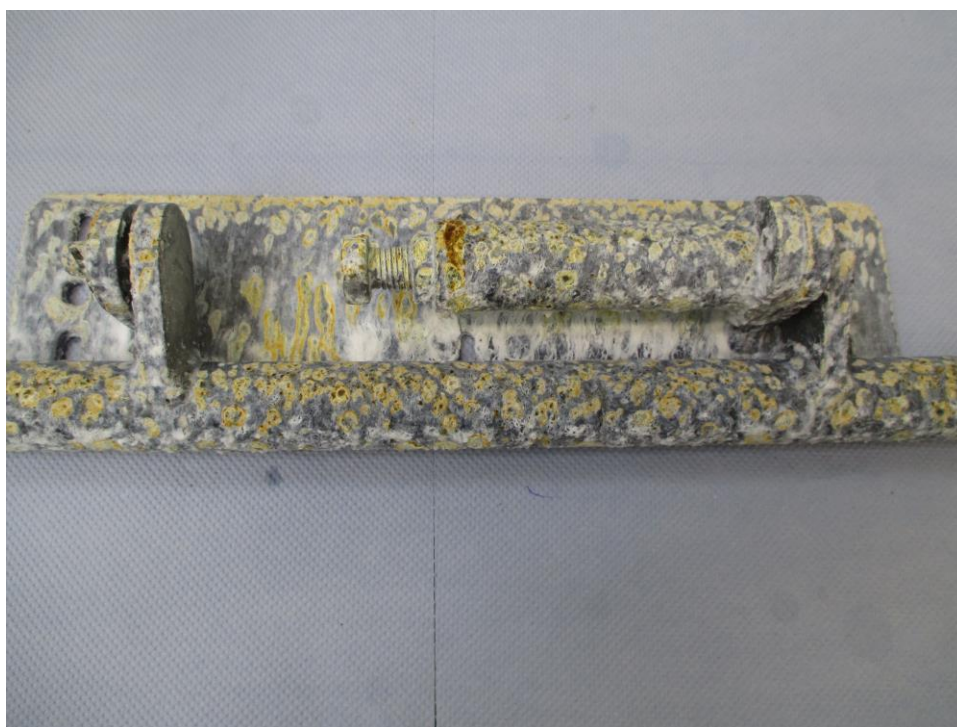
The sample showed a small area of red ferrous corrosion on the tube arm adjacent to the nut 20mm x 10mm and small area on the left hinge.

The general condition of the sample showed a significant amount of small spots of red ferrous corrosion 1.0mm maximum size and a significant amount of yellow corrosion product and total white zinc corrosion, the spring tension mechanism function worked satisfactory (see photograph after 336 hours).

Fig 5: Photograph showing the condition of the Sample after 336 hours Salt Spray Test

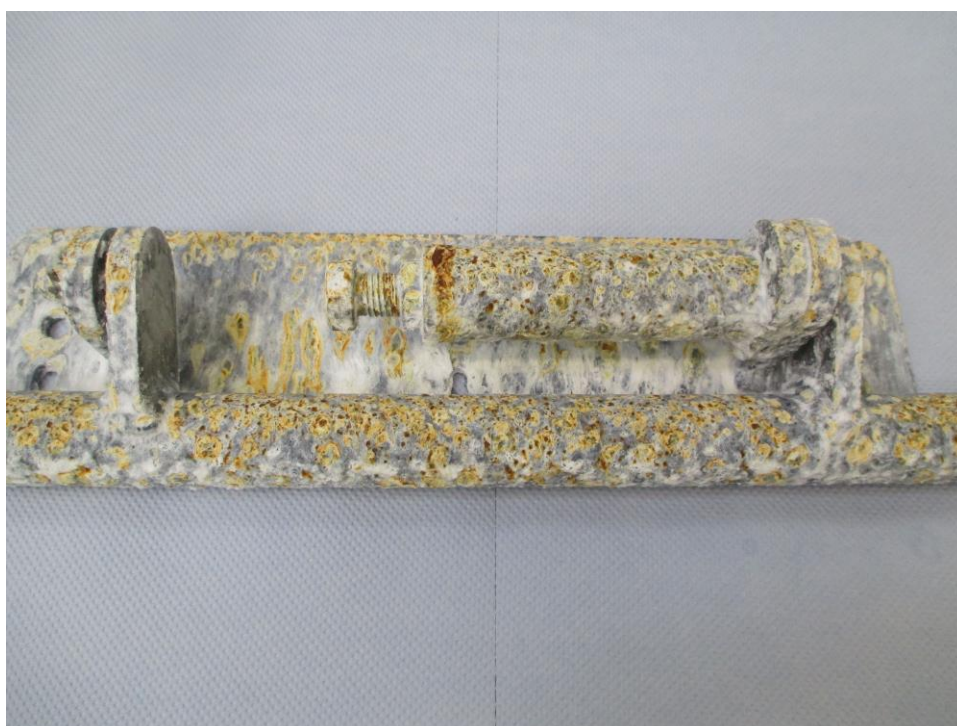
The sample showed an area of red ferrous corrosion on the tube arm adjacent to the nut and small area on the left hinge.

The general condition of the sample showed an significant - almost total amount of small spots of red ferrous corrosion 2.0mm maximum size and a significant - almost total amount of yellow corrosion product and total white zinc corrosion (see photograph after 504 hours).

Fig 6: Photograph showing the condition of the Sample after 504 hours Salt Spray Test

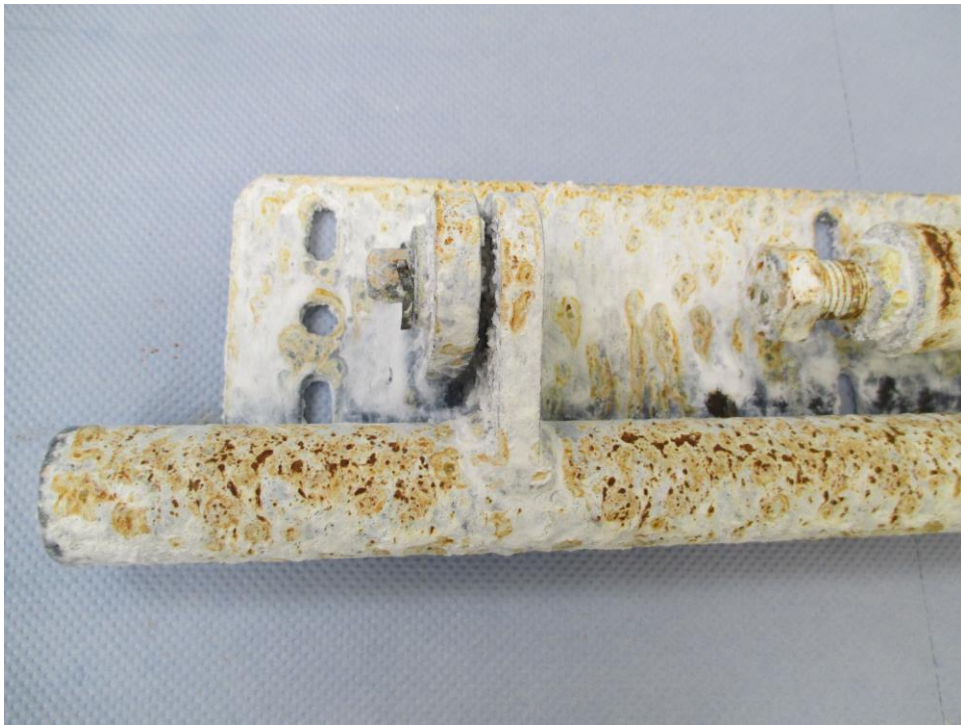
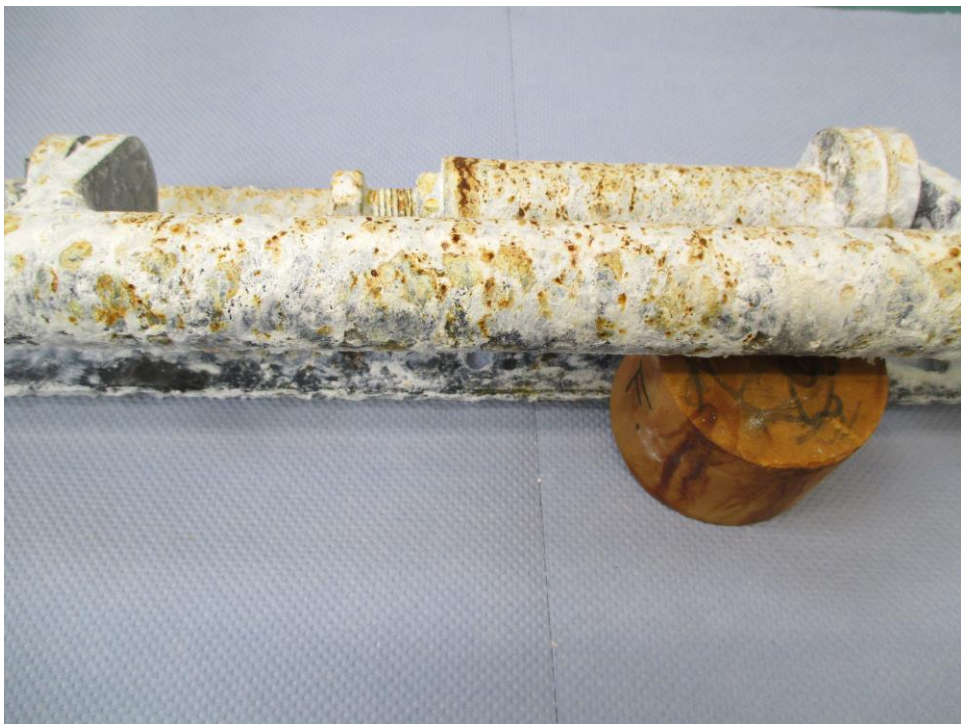
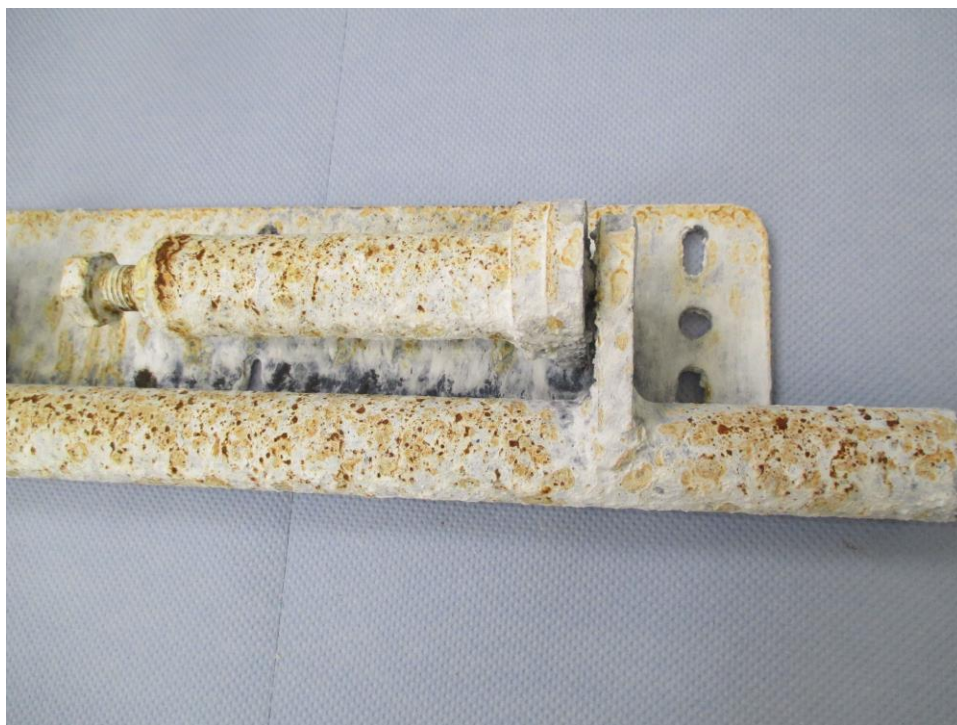
The sample showed an area of red ferrous corrosion on the tube arm adjacent to the nut and small area on the left hinge.

The general condition of the sample showed a significant amount of small spots of red ferrous corrosion 3.0mm maximum size and a significant amount of yellow corrosion product and total white zinc corrosion, the spring tension mechanism function worked satisfactory (see photographs).

The finish applied to the Galvanised Steel / Tube Assembly Sample tested, **failed to withstand** 672 hours Salt Spray Test requirement without the formation of red ferrous corrosion.

Fig 7: Photograph showing the condition of the Sample after 672 hours Salt Spray Test

Fig 8: Photograph showing the condition of the Sample after 672 hours Salt Spray Test

Fig 9: Photograph showing the condition of the Sample after 672 hours Salt Spray Test
